Teton County Historic Site Survey

historic name Snake River Bridge Piers and Jetty

other name/site number Jackson-Wilson Bridge Piers

Narrative Description

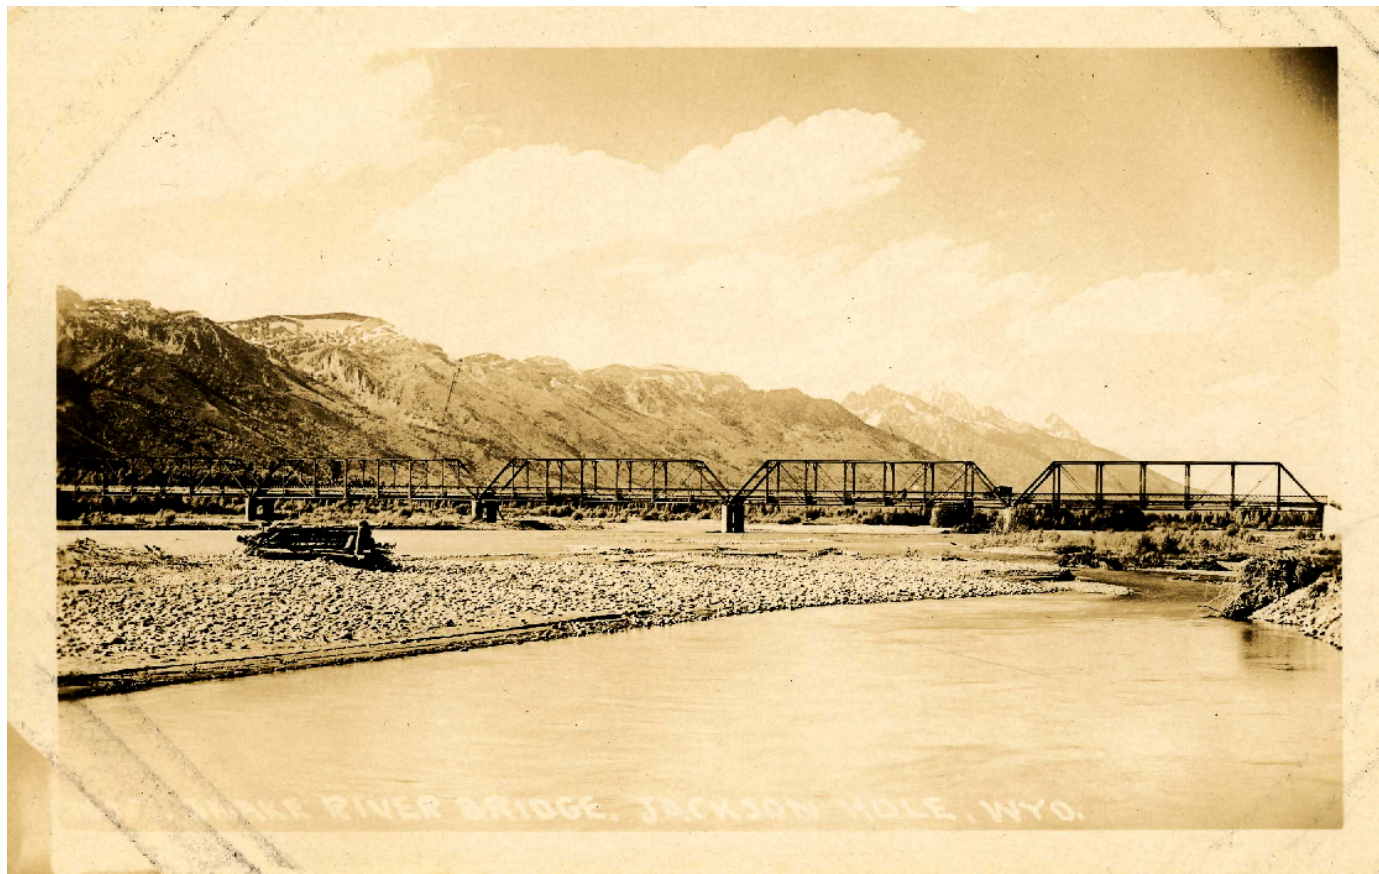
Snake River Bridge east of Wilson, undated postcard. Close analysis shows a 1920s automobile on the bridge near the fourth set of piers (from the west). Postcard from collection of Michael Cassity.

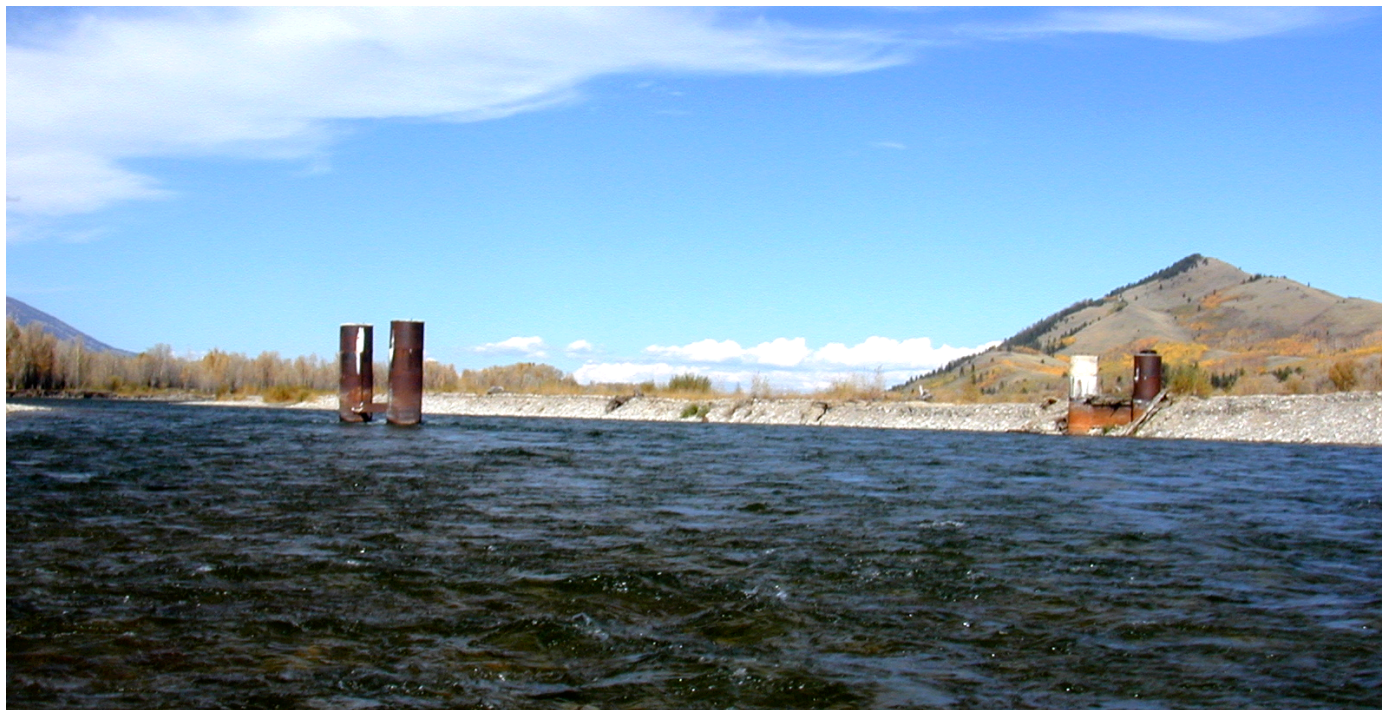
Snake River Bridge Piers east of Wilson, Wyoming, western (first and second) two sets of piers. Looking northeast. Photo: Michael Cassity, 2004.

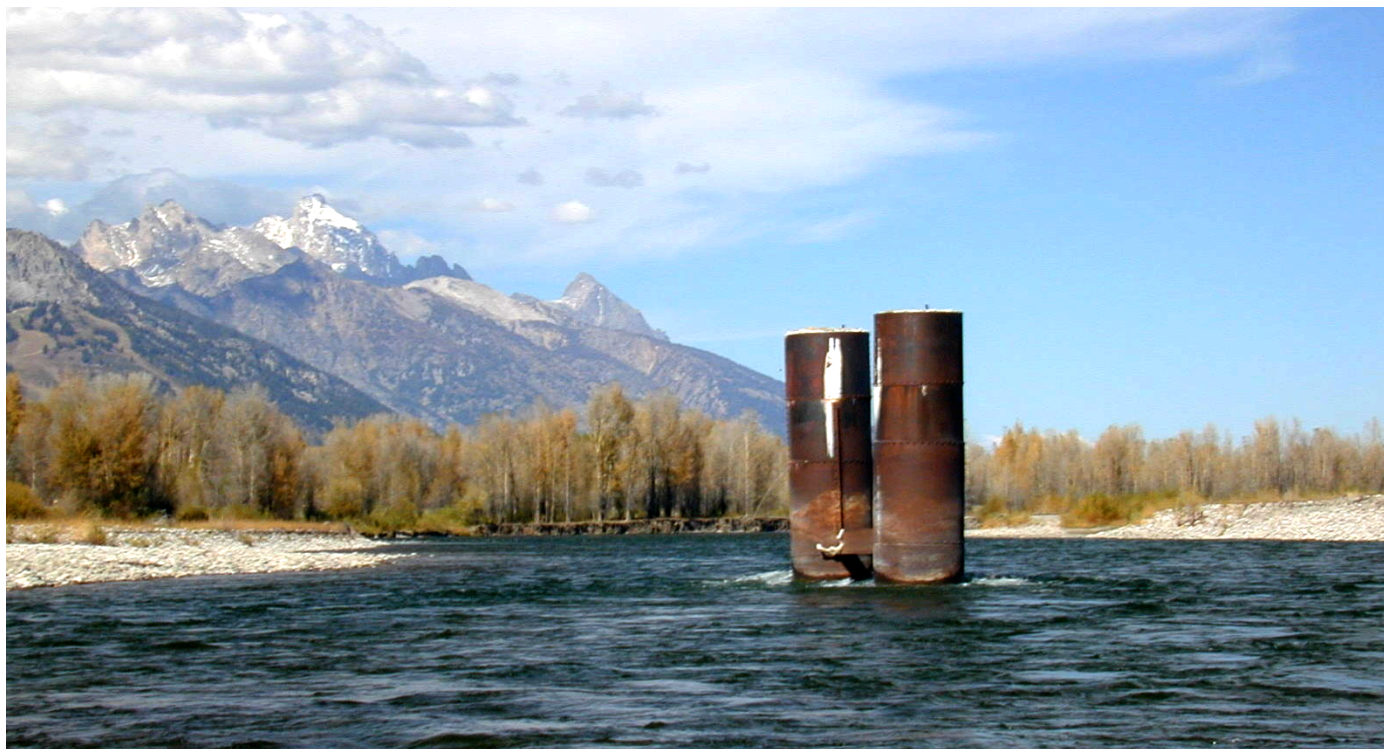
Snake River Bridge Piers, east of Wilson, Wyoming, westernmost piers. Looking north. Photo: Michael Cassity, 2004.

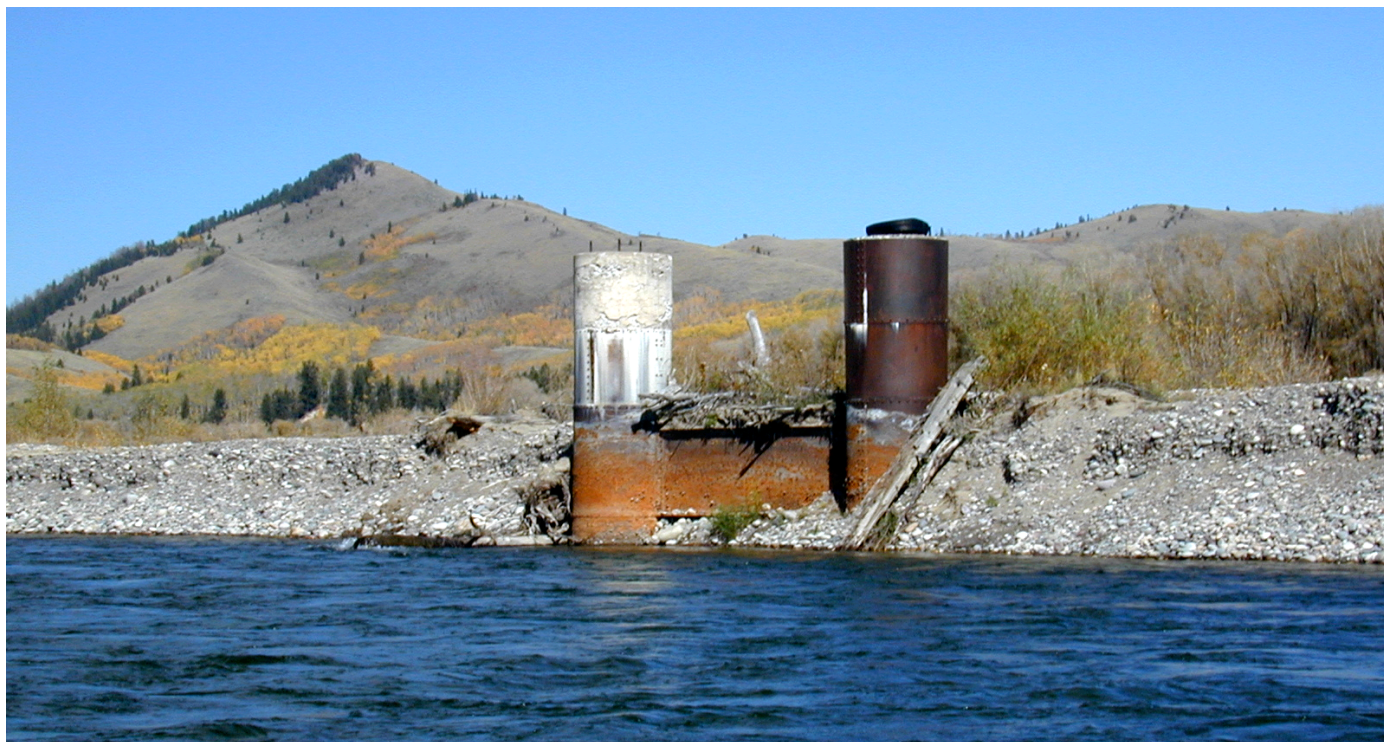
Snake River Bridge Piers, east of Wilson, Wyoming, second set of piers from the west. Looking northeast. Photo: Michael Cassiv. 2004.

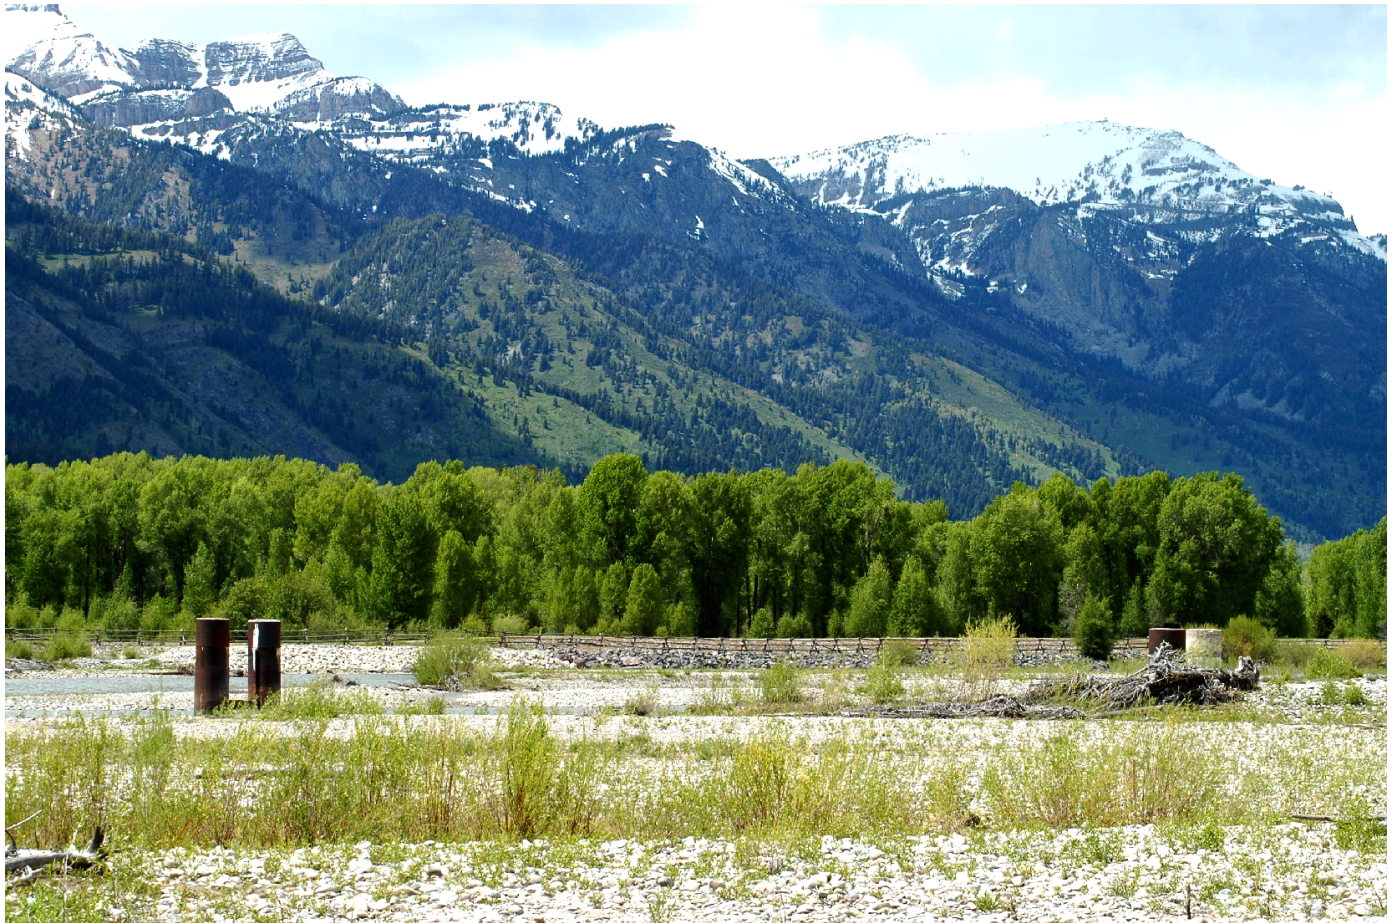
Snake River Bridge Piers, east of Wilson, Wyoming, pier sets one and two from the west. Looking northwest. Unlike other survey photos, taken in the fall of 2004, both piers are out of the water in the spring of 2005. Photo: Michael Cassity, 2005.

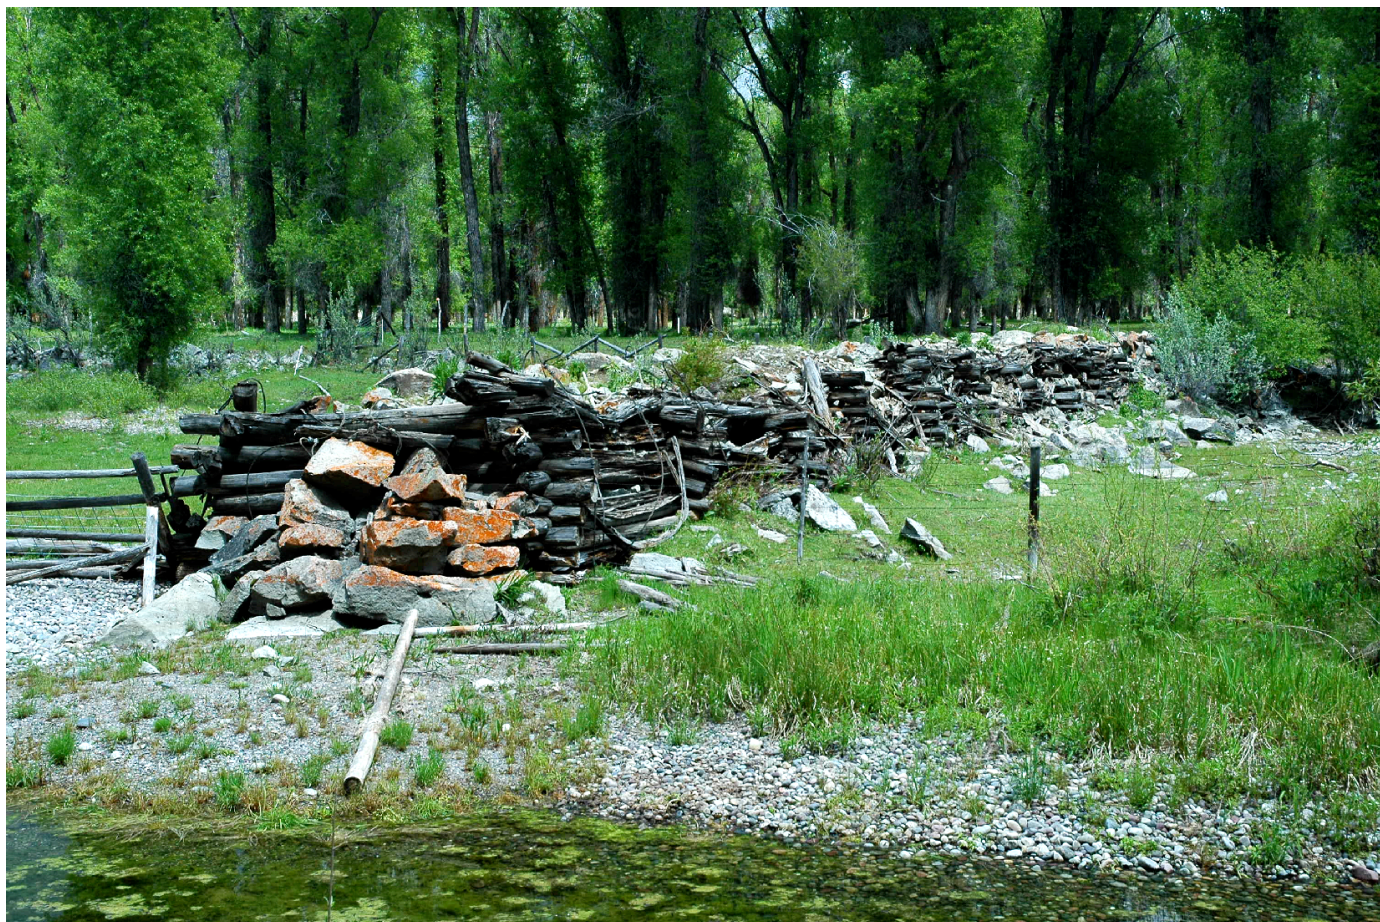
The rock and log crib jetty is a linear feature approximately eight feet tall that stretches generally east and west for a distance of about one hundred feet. Cribs made of logs coped with saddle notches to attach to each other in a line and then filled with rock make this a sturdy barrier to riverine erosion. Because of the change in the river channel, so that it is no longer a braided river in this segment to the extent that it was in earlier years, the jetty is now on dry land and is used as a part of a network of fences to form a barrier to grazing livestock. The rock used in the cribs is sharp and was clearly brought here for this use and contrasts markedly from the rounded river rocks in the flood plain.

Jetty for Snake River Bridge, east of Wilson, Wyoming. Looking east. Photo: Michael Cassity, 2005.

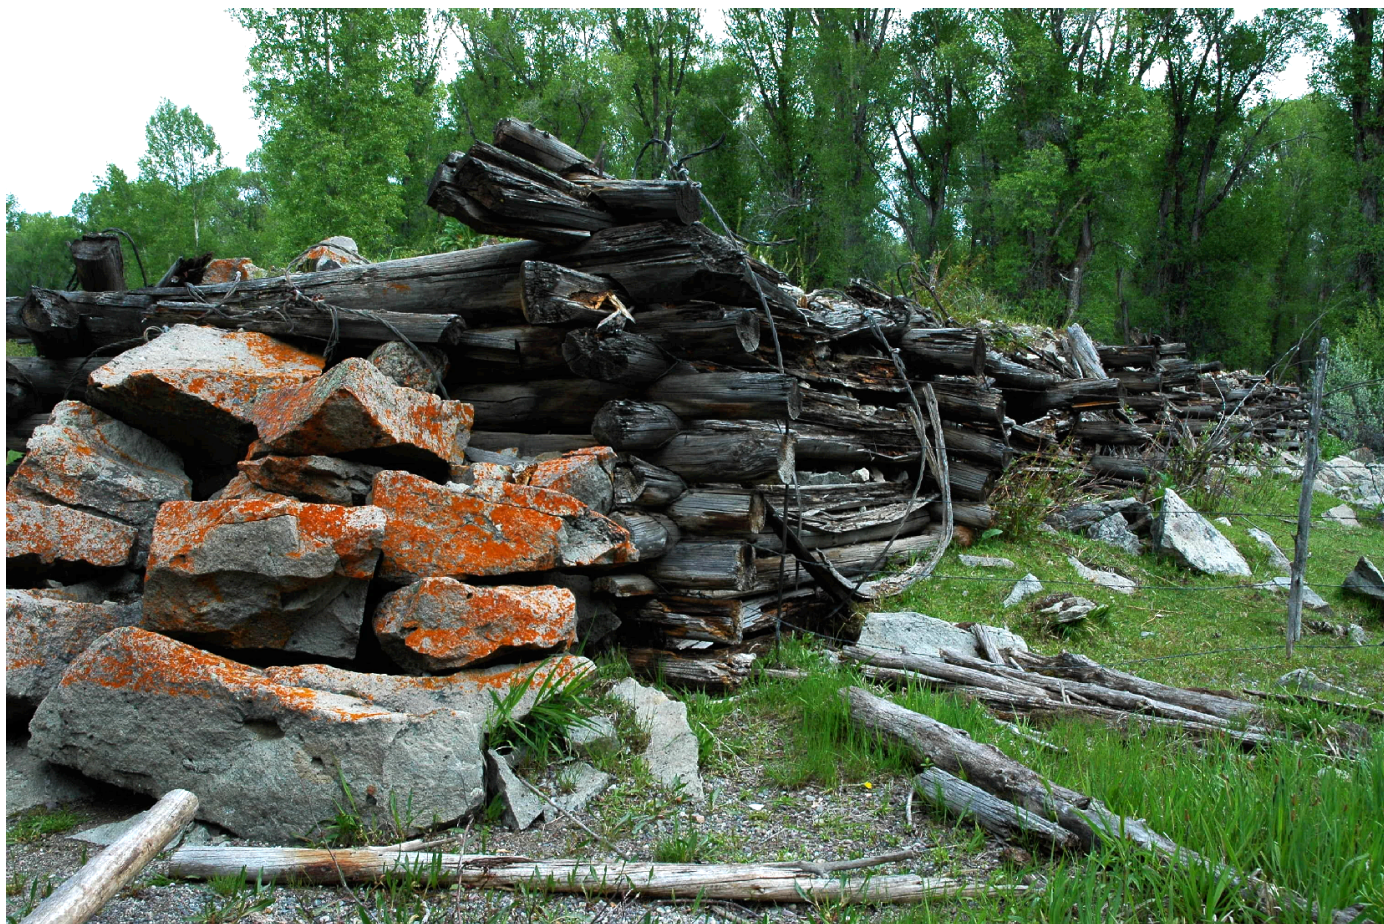
Jetty for Snake River Bridge, east of Wilson, Wyoming. Looking east. Photo: Michael Cassity, 2005.

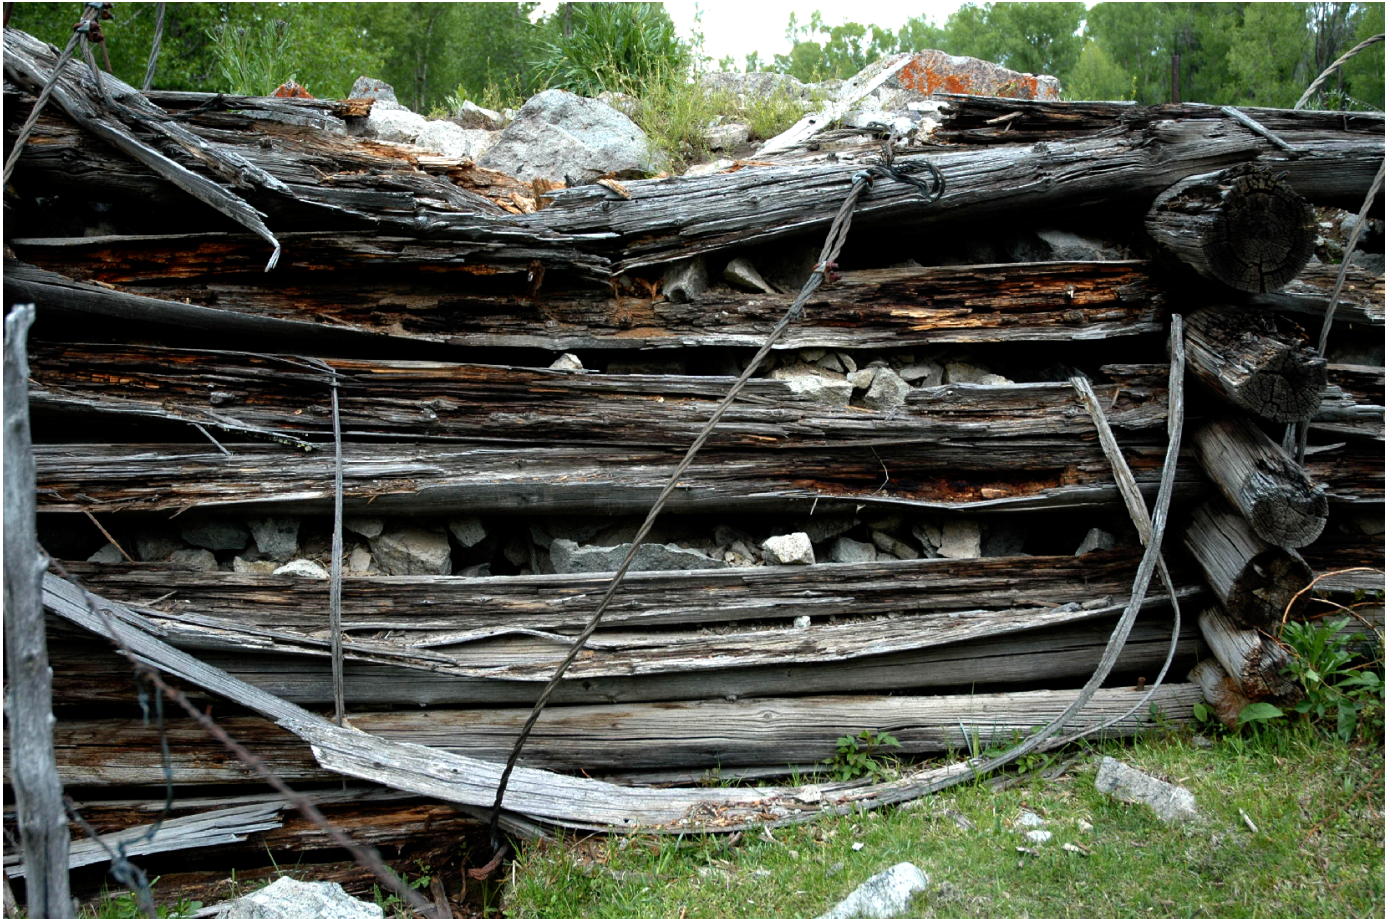
Jetty for Snake River Bridge, east of Wilson, Wyoming. Looking north. Photo: Michael Cassity, 2005.
